THE FAKE CISCO

Hunting for backdoors in
Counterfeit Cisco devices

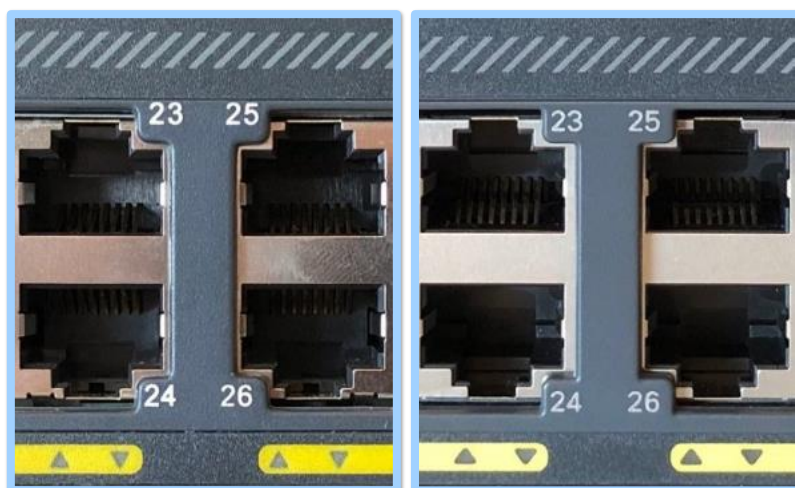
Figure 1. The suspected counterfeit switch (on the left) has port numbers in bright white, while the known genuine device has them in grey. The text itself is misaligned. The triangles indicating different ports are different shapes.

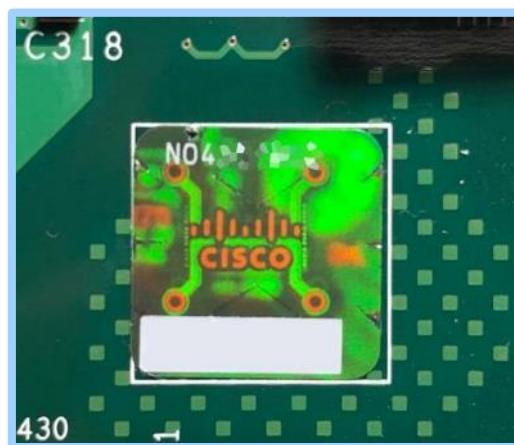
Figure 3. Legitimate holographic sticker which was absent on both counterfeit units.

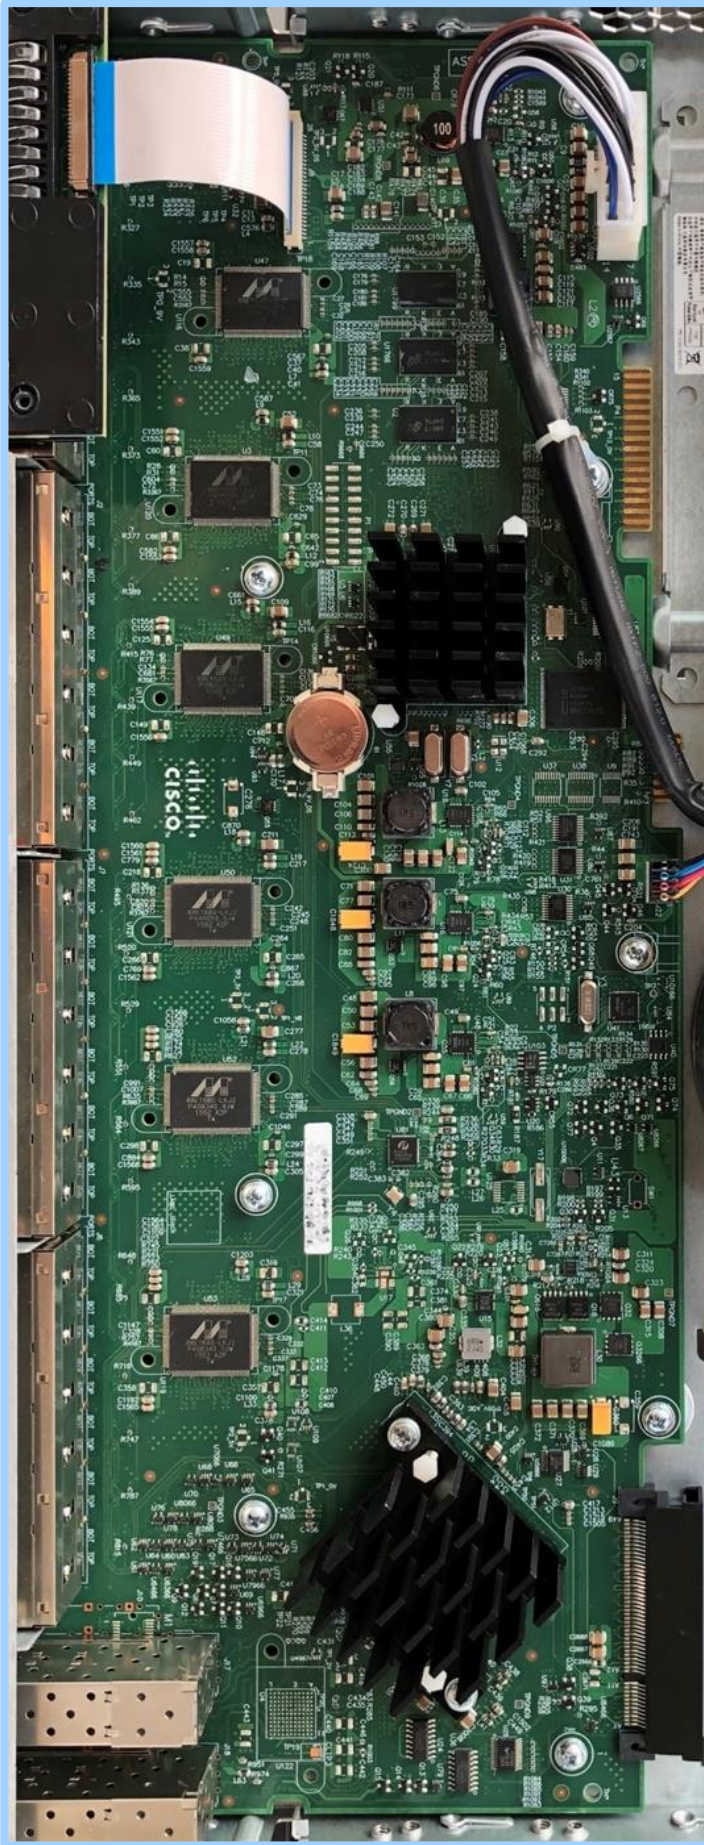
Figure 6. Counterfeit B, internal view.

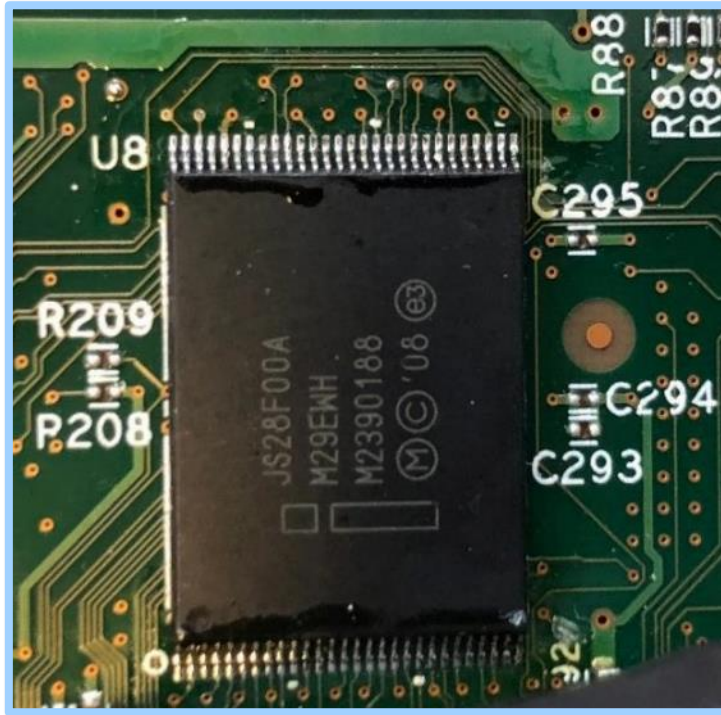
Figure 7. U8, an 1Gbit NOR Flash. PCB rework evidence on the Counterfeit A unit: soldering flux residue on and around the Flash IC is present.

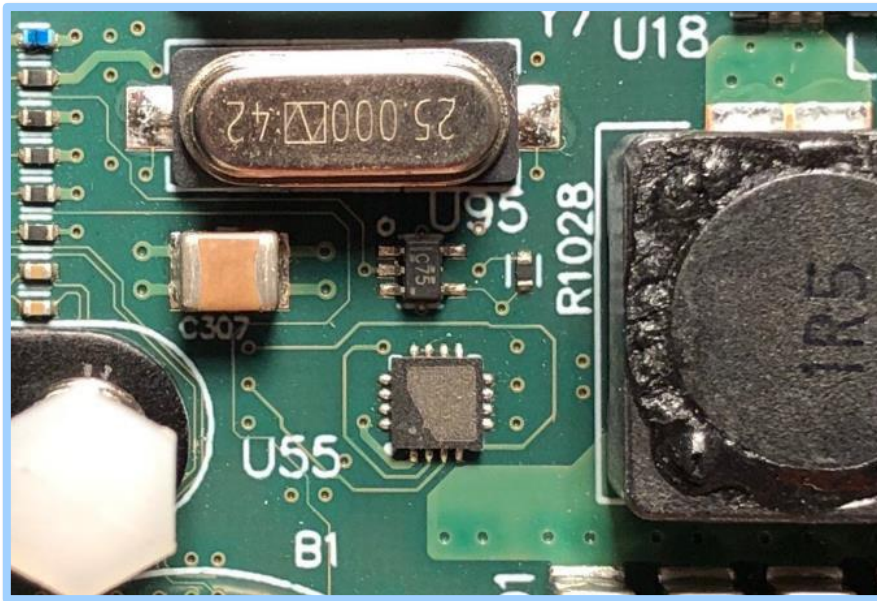
Figure 10. U55, an unknown component with top marking removed.

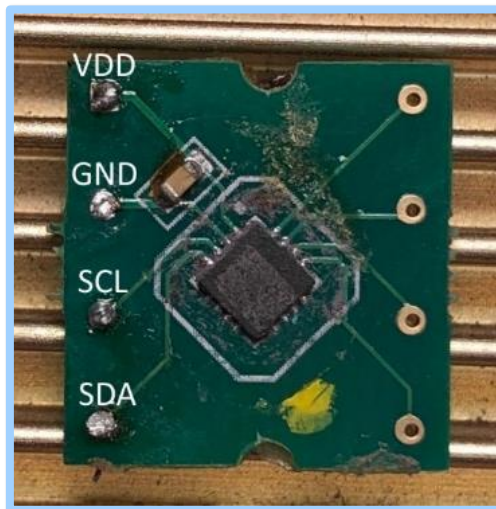
Figure 19. The implant PCB, disconnected from the unit, with the resin blob removed. As with Counterfeit B, the top marking was erased.

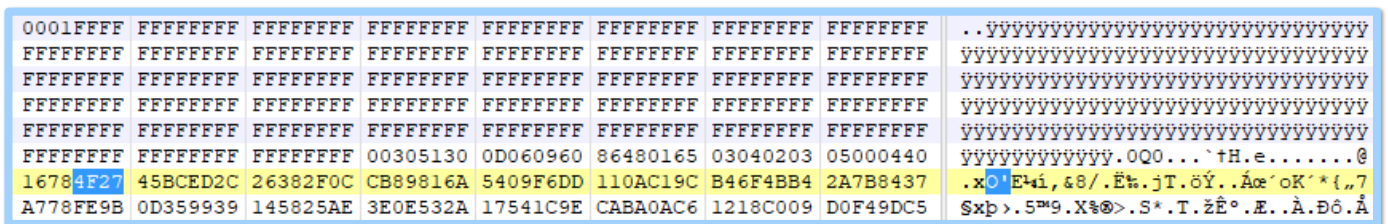
Figure 21. Decrypted BROM signature.

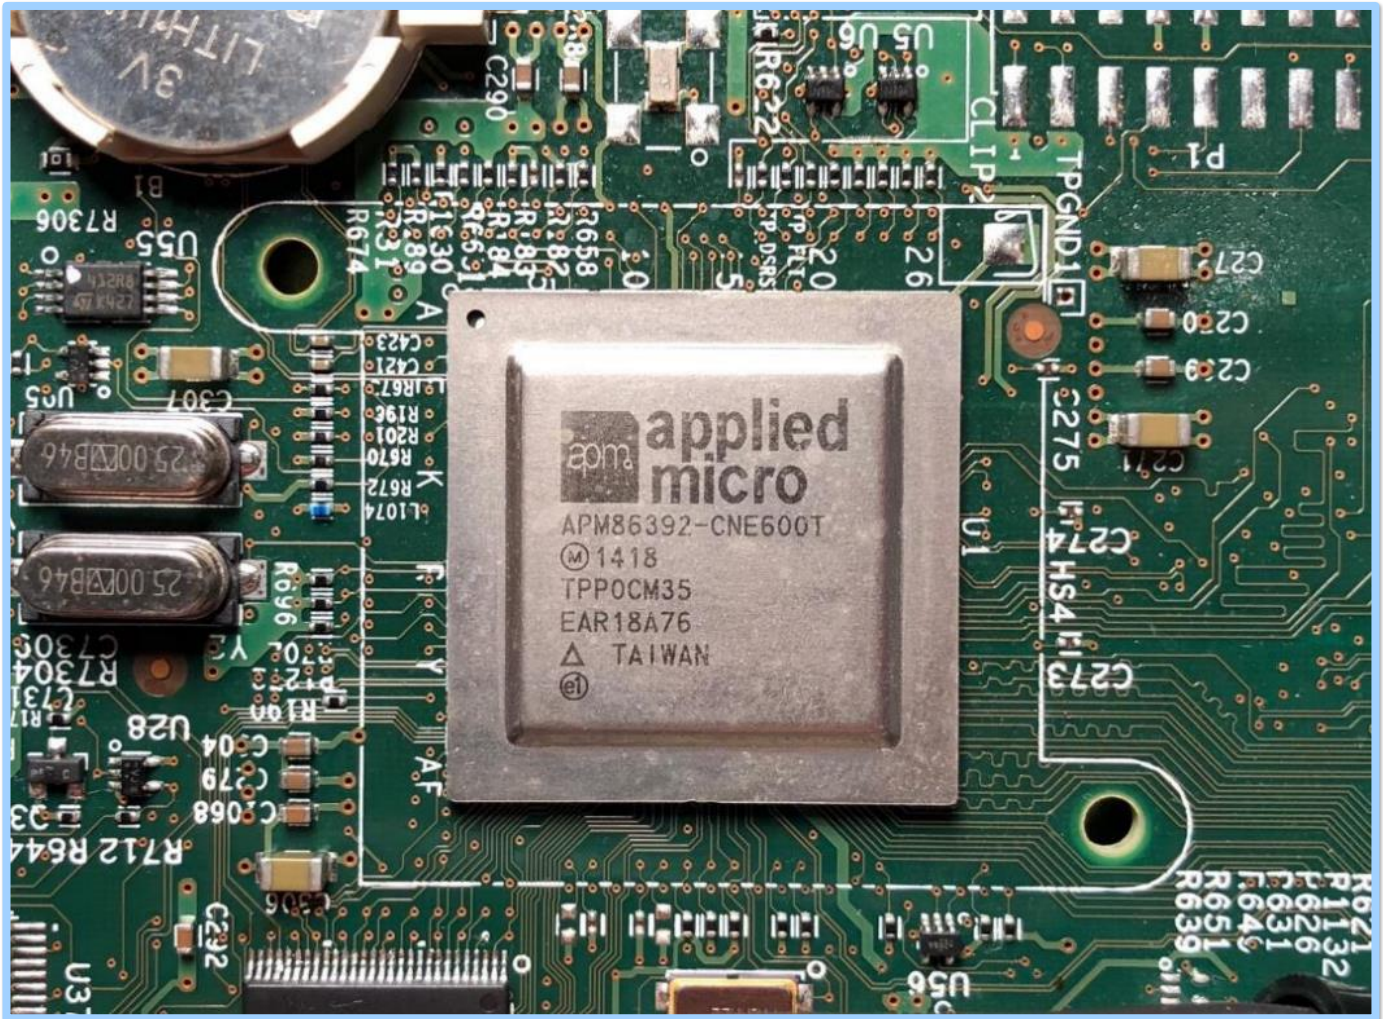
Figure 23. U1, the main SoC in situ in Counterfeit A. A couple of crystals and a backup Lithium battery can be seen around.
