Breaking Secure Bootloaders

Project One – The SDM660 Android Bootloader

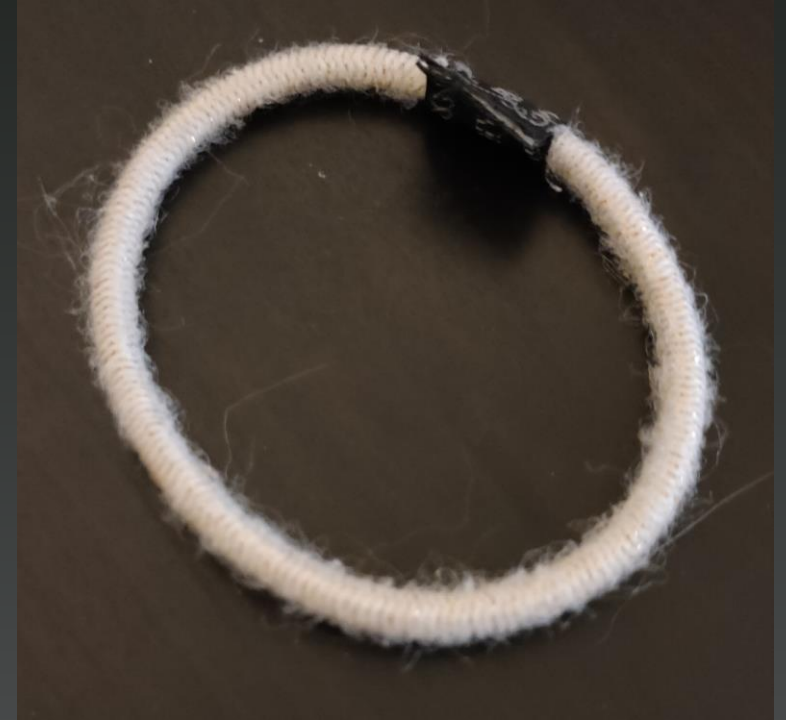
Instead, a hair tie was wrapped around the power and volume down buttons

This caused a boot loop which allowed USB access for sufficient time to test the overflow

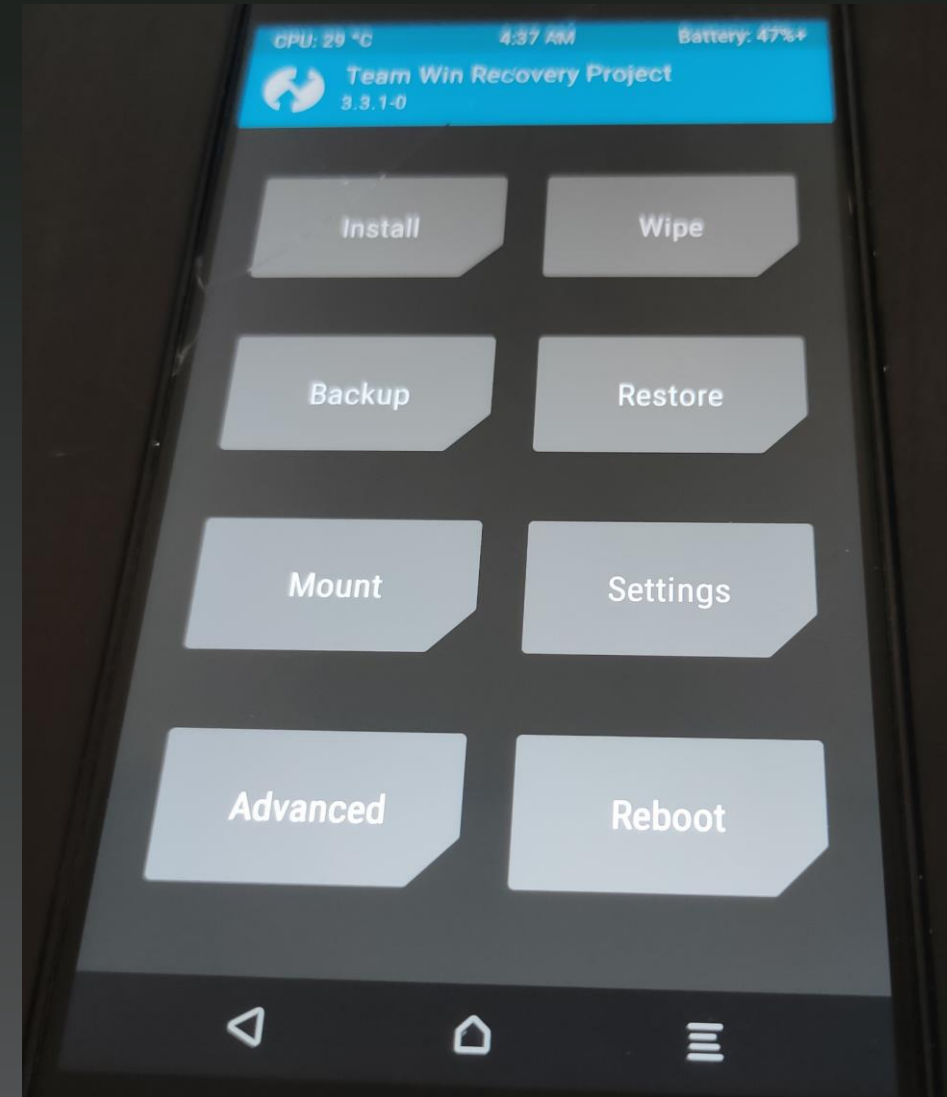
By accessing the unencrypted userdata partition, one can remove lockscreen restrictions

By using a custom recovery image, such as TWRP, or by modifying the Operating System, it is possible to gain access to all apps and stored data

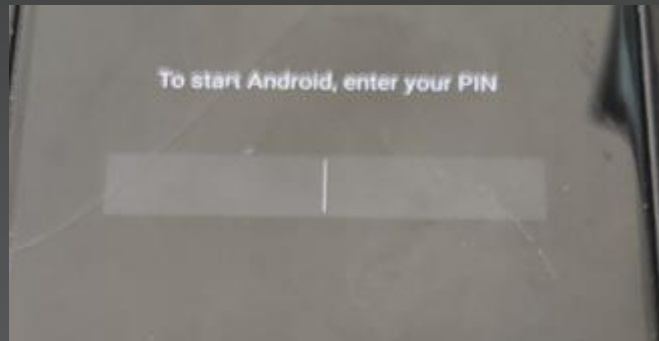
The Android “boot” image, where the kernel and root filesystem are stored, is not encrypted

It is possible to add a reverse shell to the image, to access the data later
