Ghost in the Wireless, iwlwifi edition

Nicolas Iooss and Gabriel Campana
nicolas.iooss@ledger.fr
gabriel.campana@ledger.fr

Abstract. Wi-Fi replaced Ethernet and became the main network protocol on laptops for the last few years. Software implementations of the Wi-Fi protocol naturally became the targets of attackers, and vulnerabilities found in Wi-Fi drivers were exploited to gain control of the OS, remotely and without any user interaction. However, not much research has been published on Wi-Fi firmware, outside of Broadcom models. This article presents the internals of an Intel Wi-Fi chip. This study, mostly conducted through reverse engineering, led to the discovery of vulnerabilities such as arbitrary code execution on the chip and secure boot bypass, which were reported to the manufacturer.

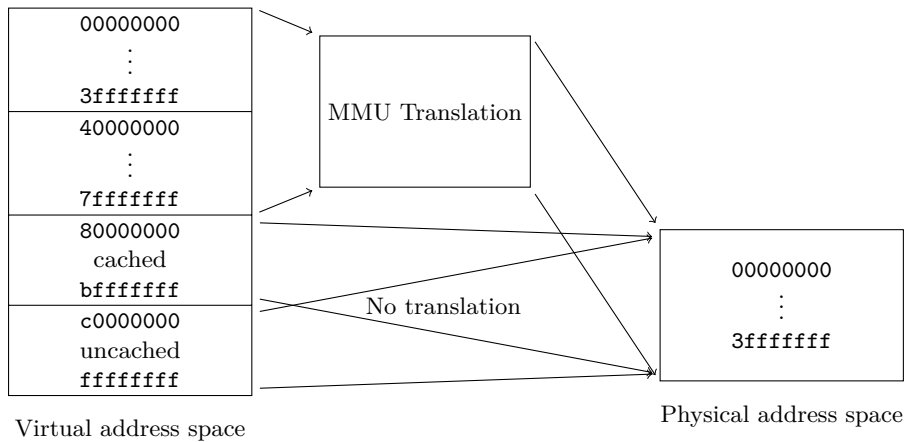
but are never translated by the MMU. For example, the section loaded at address `c0080000` is in fact loaded at physical address `00080000` and uses high bits in order to bypass the MMU translation. This is illustrated in figure 2.

Fig. 2. Virtual and physical address spaces of ARC700 microcontrollers
